DEVELOPMENT OF NOVEL AND COST-EFFECTIVE CORROSION RESISTANT COATINGS  
FOR HIGH TEMPERATURE GEOTHERMAL APPLICATIONS

## IN-SITU TESTING OF AN LMD-HEA2 COATED TURBINE COMPONENT SECTION IN GEOTHERMAL ENVIRONMENT

Dagur Ingi Ólafsson

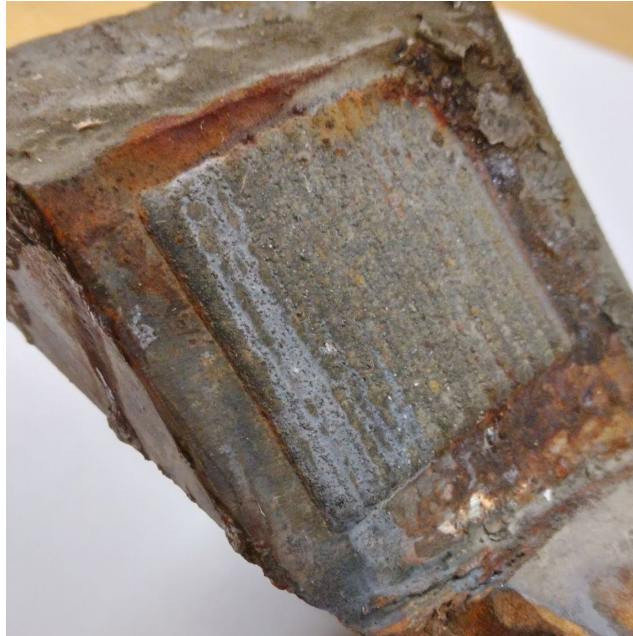
After testing, the sample was transferred to IceTec, where it was inspected and subsequently analysed for corrosion in an optical and scanning electron microscope. The sample was heavily corroded around the coated patch, and the A470 base material showed strong discolouring, rust patches and flaking of the material. Meanwhile, the coated patch seemed to have resisted the conditions significantly better. The edges of the coated patch were discoloured while the central parts seemed much less affected, with some small, yellow-brownish dots here and there. This indicates corrosion of the base material underneath the edges of the coated patch. It is also possible that the discolouring of the coated part of the sample is rust that has migrated from the base material surface onto the coating. The coated sample can be seen in Figure 3 below.

Figure 3 – The sample after transferral to IceTec

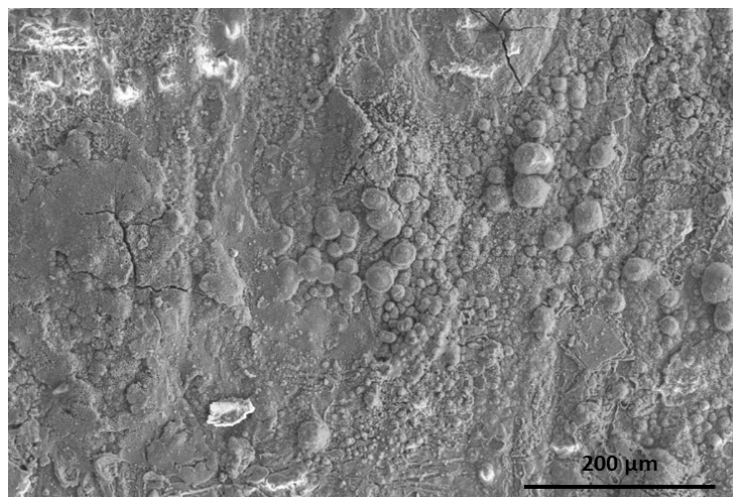
The surface of the sample was analysed using a scanning electron microscope (SEM) with **energy dispersive X-ray spectroscopy (EDX)**. The bare A470 substrate was found to have iron-oxides covering the surface, as could be seen from optical inspection. The rust layer was cracked and, in some places, grainy as can be seen in Figure 4.

Figure 4 - Scanning electron microscopy image of the bare substrate surface.

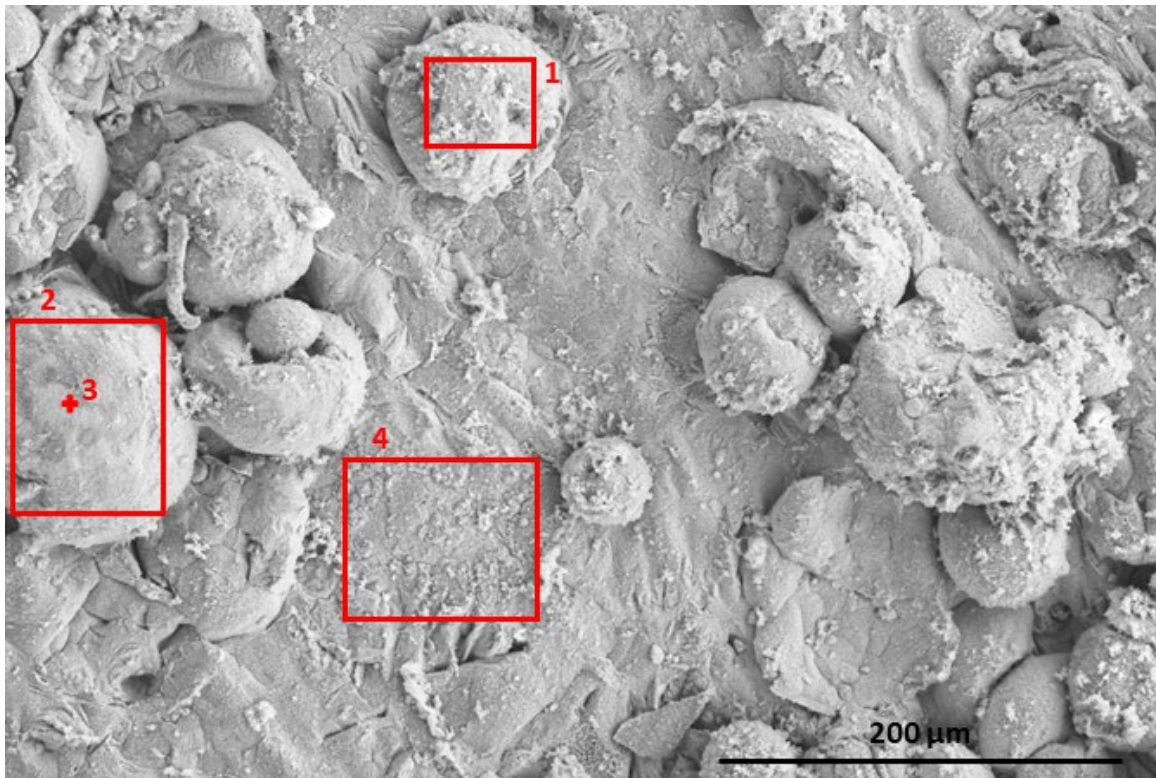
EDX analysis of the coated surfaces showed most of the coating having reacted to the oxygen-heavy test conditions by forming a thick chromium-oxide layer on top of the coating. Some iron oxides are also seen on the surface. The coating surface was grainy in places, littered by spheres of coating material from the cladding process. Some of these spheres seemed to have formed iron oxides on their surfaces, as can be seen in Figure 5 and Table 3.

Figure 5 - SEM image of the coated surface of the sample, showing spherical sputter on the coating. Three areas and one point were chosen for elemental analysis.

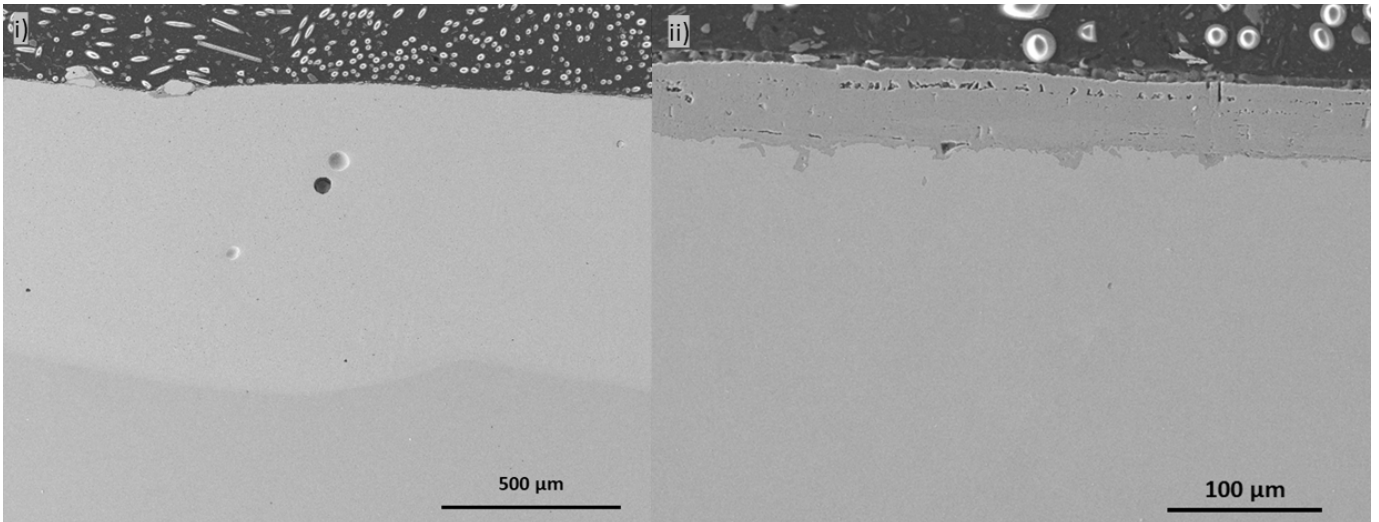
A cross-sectional sample was cut from the larger piece and analysed with an SEM and EDX. The cross-sectional analyses confirmed the formation of thick chromium oxide layers on the surface of the coating. Meanwhile, the bare base material had thick patches of iron oxides on its surface due to the interaction with oxygen. Corrosion was found to have started to penetrate slightly underneath the coating at the coating-substrate interface. The

substrate under the coating away from the interfaces was found to be unaffected by exposure while the bare substrate was heavily affected as can be seen in Figure 6.

Figure 6 – i) Cross-section of the coated sample, showing the coating and the underlying substrate, ii) surface of the exposed substrate, showing a rust layer on top of the A470 steel up to 75 μm thick as well as pits.

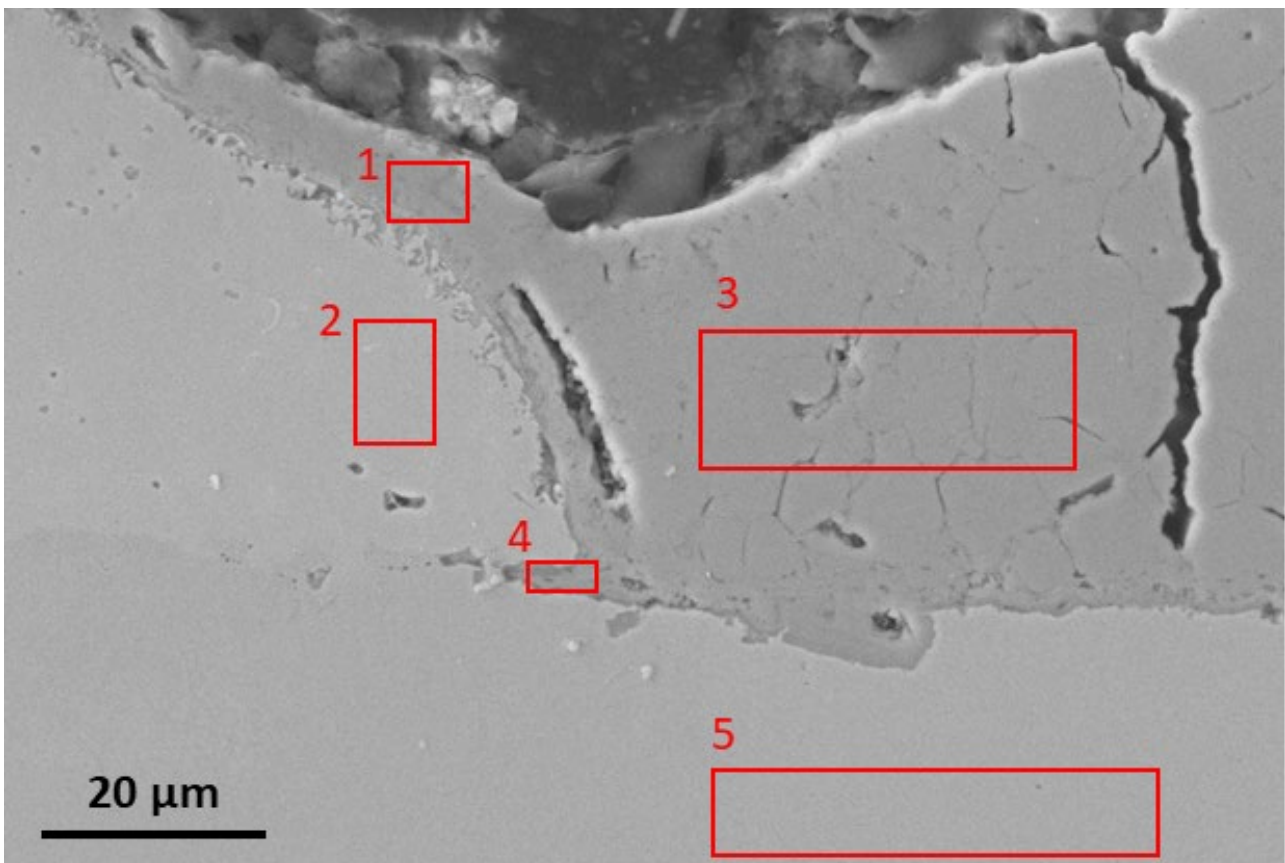
At the coating-substrate interface, corrosion was seen to have occurred underneath the coating itself, emphasizing the importance of good coating coverage. In addition to corrosion of the underlying substrate, the coating composition at the intersection was found to have much larger portion of iron in comparison to the other four elements that make up the LMD-HEA2 coating. This could be due to diffusion of the elements out of the coating or simply an artifact of the cladding process. An SEM image, showing EDX analysed locations can be seen in Figure 7 along with the elemental analysis itself in Table 4.

Figure 7 - EDX analysis of the coating-substrate interface, showing locations marked for chemical analysis.

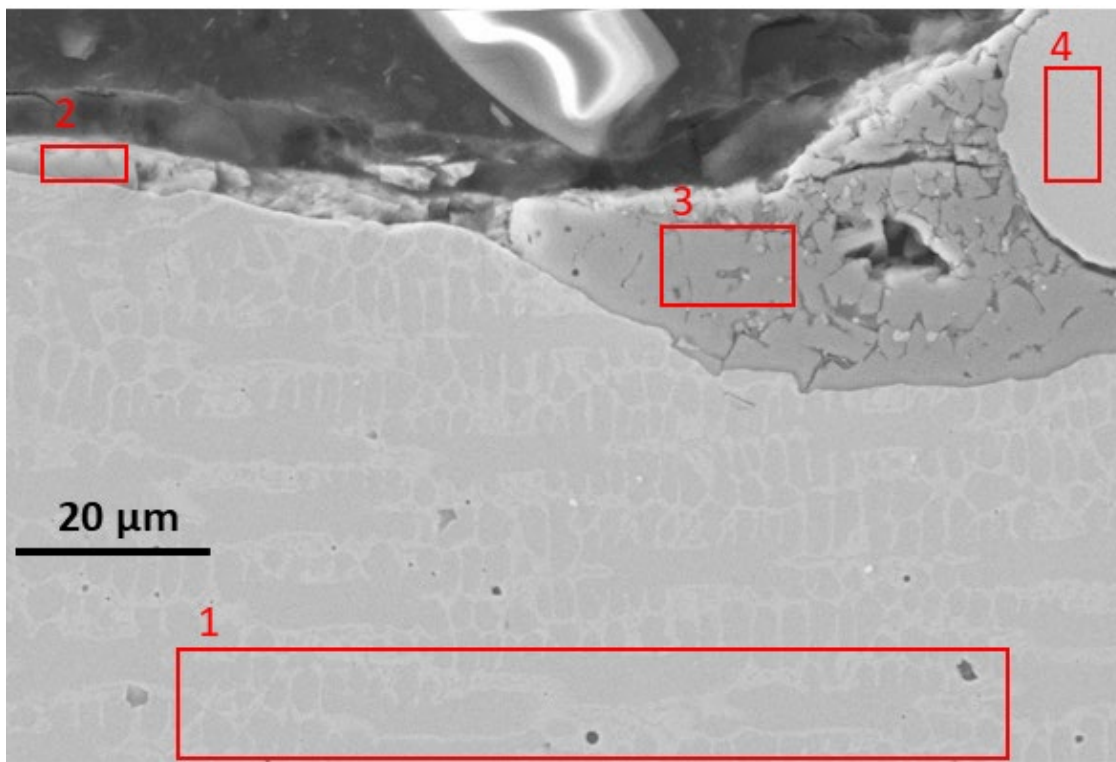
Figure 8 - SEM image of the surface of the coating, showing spherical artifacts from the cladding process along with chromium oxide layer.
