CreepImage - Development of a long term creep monitoring image based technique

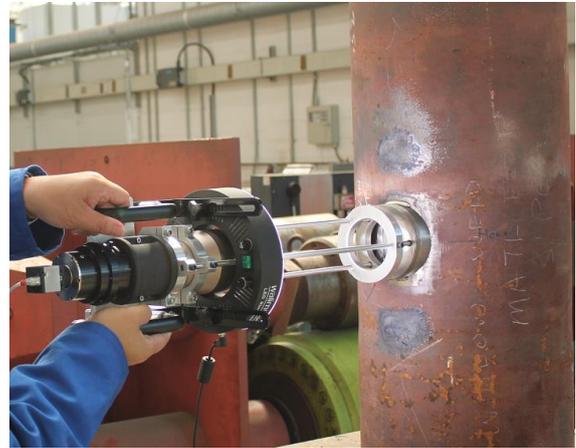
Figure 1 Rapid CreepImage inspection performed using a camera positioning jig.

Digital camera equipped with a telecentric lens has been integrated into a compact prototype system with a three-leg based positioning mechanism, which allows quick deployment on a power plant pipe. A protective casing for the inspection coupon was also designed and trial installed on an ex-service pipe. A micro laser cladding procedure was formulated to produce a high-density grid pattern on the inspection coupon. A remaining life prognosis method based on the Omega model was incorporated into the system.
