DEVELOPMENT OF NOVEL AND COST-EFFECTIVE CORROSION RESISTANT COATINGS  
FOR HIGH TEMPERATURE GEOTHERMAL APPLICATIONS

## IN-SITU TESTING OF AN LMD-HEA2 COATED TURBINE COMPONENT SECTION IN GEOTHERMAL ENVIRONMENT

Dagur Ingi Ólafsson

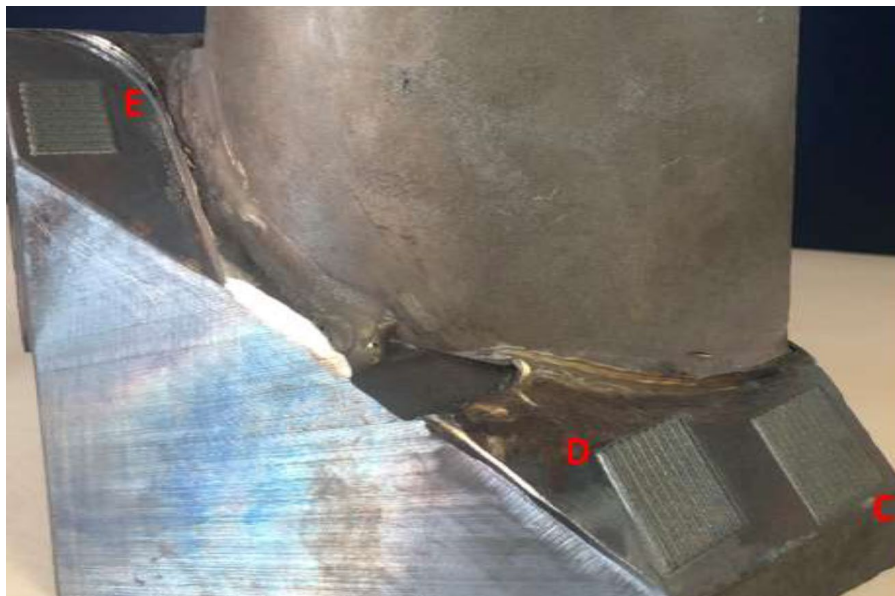
Figure 1 - Turbine component for testing at ON with three coating areas

Patch C was subsequently chosen for testing in-situ at ON.
